# Manhole Inspection Summary

Manhole # S53C\_\_008MH

Insp Date: **6/12/08 9:28 AM**

**Location** Address: **3231 esther place**

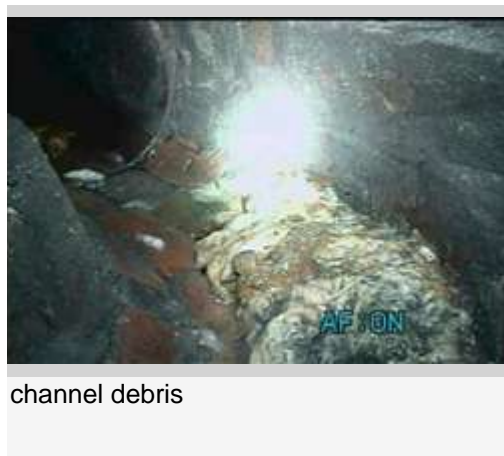
Defect 4

Condition: ☐ Sound ☐ Cracked ☐ Root Intrusion ☐ Deteriorated ☐ Leaks ☒ **Debris**

bench debris

channel debris

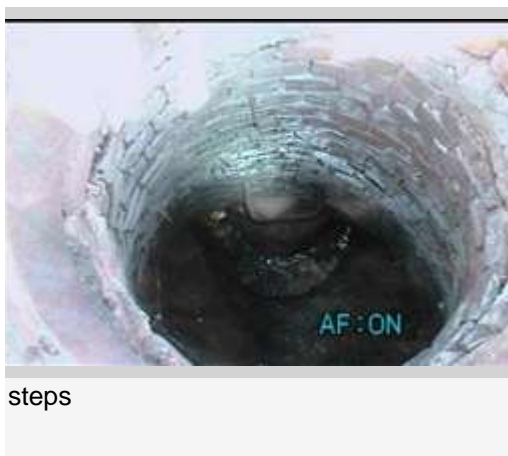
Defect 3

Count: **3** Missing: **2** ☒ **Corroded**

steps

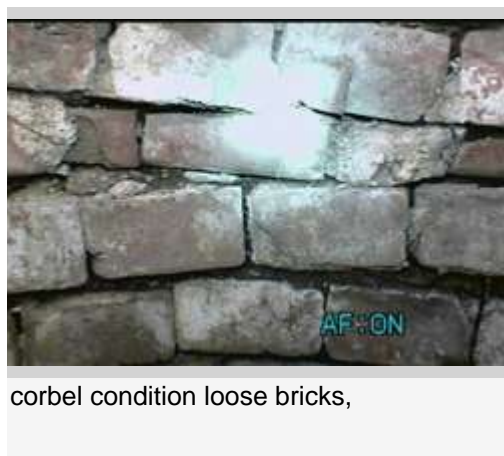
Defect 2

Condition: ☐ Sound ☐ Cracked ☐ Root Intrusion ☒ **Loose Brick** ☐ Deteriorated

corbel condition loose bricks,

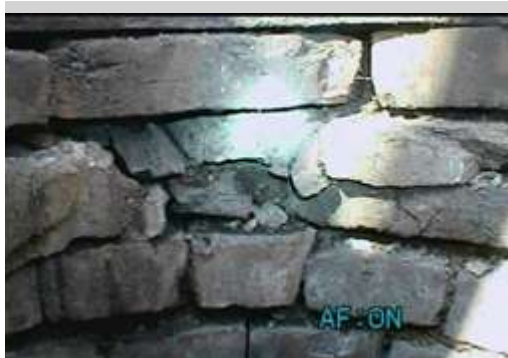
### Defect 1

Condition: ☐ Sound ☒ **Cracked** ☐ Root Intrusion ☒ **Loose Brick** ☐ Deteriorated

chimney loose bricks, cracked, frame adj

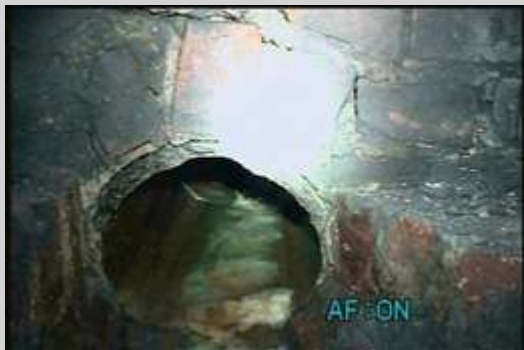
12 O'Clock Outflow

8 in. Circular Gravity Sewer  
Pipe Out @ 12 O'Clock

Pipe Material: **Clay** ☐ Pipe Lined

Invert Depth: 7.67 (ft.) Flow Characteristics: **Slow**

Deposits: ☒ None ☐ Mud ☐ Sludge ☐ Debris ☐ Grease

Infiltration: **None** Pipe Seal Cond: **Unknown**

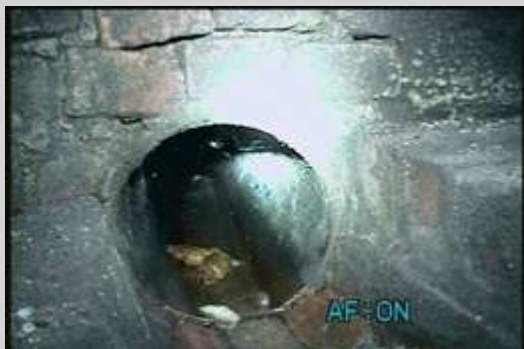
3 O'Clock Inflow

8 in. Circular Gravity Sewer  
Pipe In @ 3 O'Clock

Pipe Material: **Clay** ☐ Pipe Lined

Invert Depth: 7.61 (ft.) Flow Characteristics: **Slow**

Deposits: ☒ None ☐ Mud ☐ Sludge ☐ Debris ☐ Grease

Infiltration: **None** Pipe Seal Cond: **Unknown**
